Direct-Pickup Interference Tests of Three Consumer Digital Cable Television Receivers Available in 2005

**Technical Research Branch
Laboratory Division
Office of Engineering and Technology
Federal Communications Commission**

**OET Report
FCC/OET 07-TR-1005**

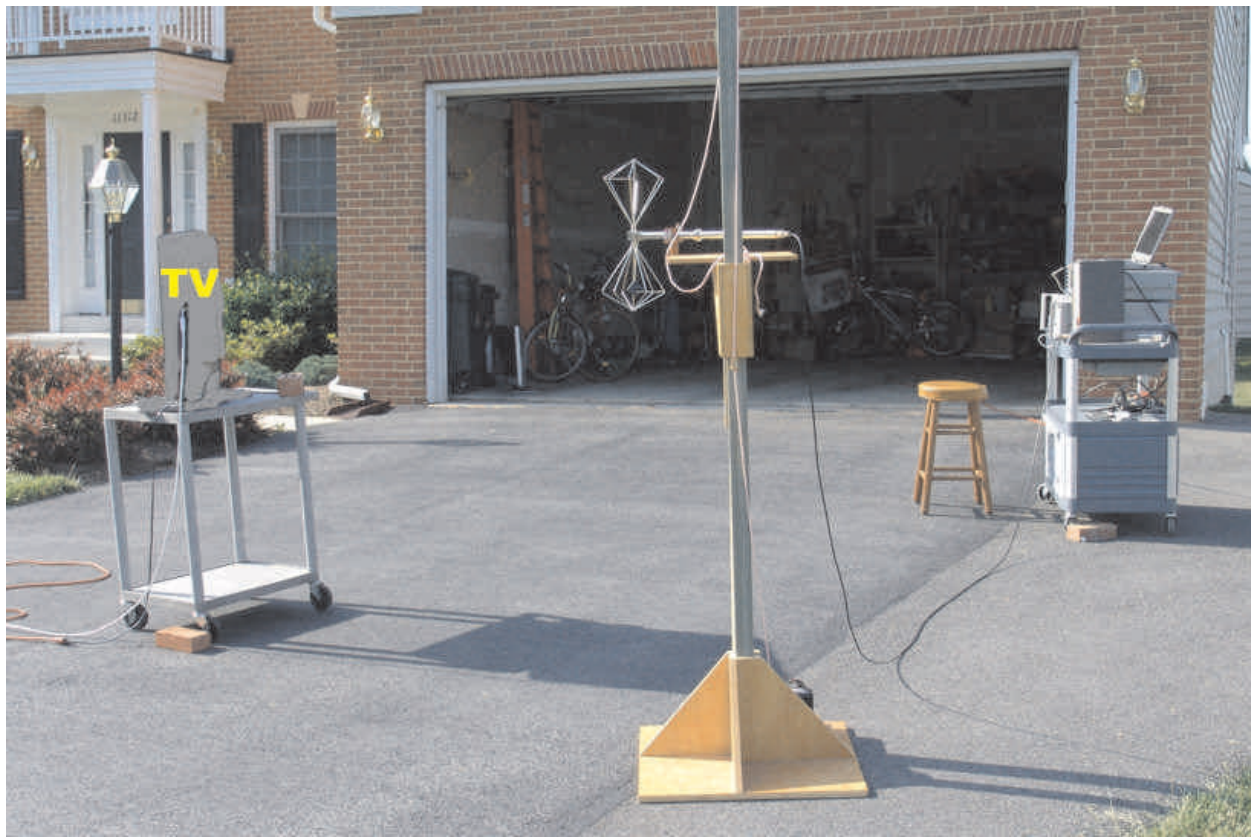
Figure 2-1. Test Site 0—No Wall

Tests of one TV were performed with both the TV and the interfering source located outdoors above an asphalt driveway. Figure 2-1 shows a photo of the test setup. Note that in this and other photographs, the TV receiver is obscured to prevent identification of brand and model. This test was performed for

comparison to the tests at site 1. The metal garage door was in the open position during the tests, as shown in Figure 2-1.

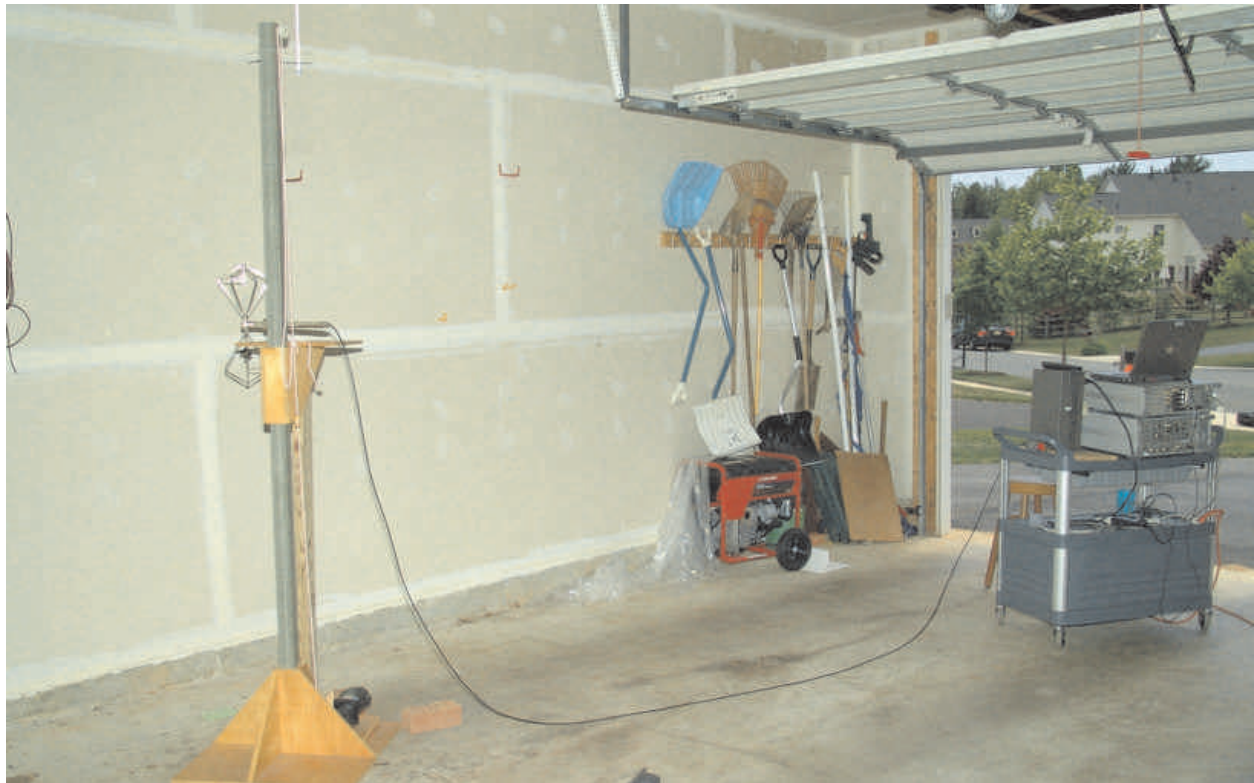
Figure 2-2. Test Site 1—Inside View of Exterior Wall

Three TVs were tested at a single-family house. The initial intent had been to place the TV inside the residence and the transmitter outside. The plan was to avoid windows in order to ensure that the interfering emission propagated through a wall rather than through a window; however, all potential test areas included either closely-spaced windows or large metallic objects (air-conditioning units, metal gas fireplace, or washer and dryer). Consequently, an exterior garage wall was selected as the barrier between the transmitter and the TV receiver. It was more convenient at this site to run the cable for TV operation outdoors than into the garage; consequently, the TV was placed outdoors for the tests and the interfering source was placed inside the garage. Figures 2-2 and 2-3 show the test setup.*

* The metal garage door was in the open position during the tests, as shown in Figure 2-2.

As was shown in Table 2-1 and the illustrations, the exterior garage wall had the same type of construction as the back and side walls of the house (wood frame with drywall inside and vinyl siding over sheathing on the outside). The only elements missing from the garage wall relative to the exterior residence walls were insulation and electrical wiring. Because the insulation in the residence walls was fiberglass with a clear plastic vapor barrier, it is not expected to contribute significantly to wall attenuation; consequently, the absence of insulation is not expected to influence the test results. While the presence or absence of electrical wiring in a wall can affect propagation, we note that, except where wall switches, overhead lights, or feeds to the second floor exist, the first floor wiring on the exterior walls extends above the floor level only to the height of the outlets (16 inches), which are spaced at 12-foot intervals; consequently, in at least some cases, its effect on propagation is likely to be small.

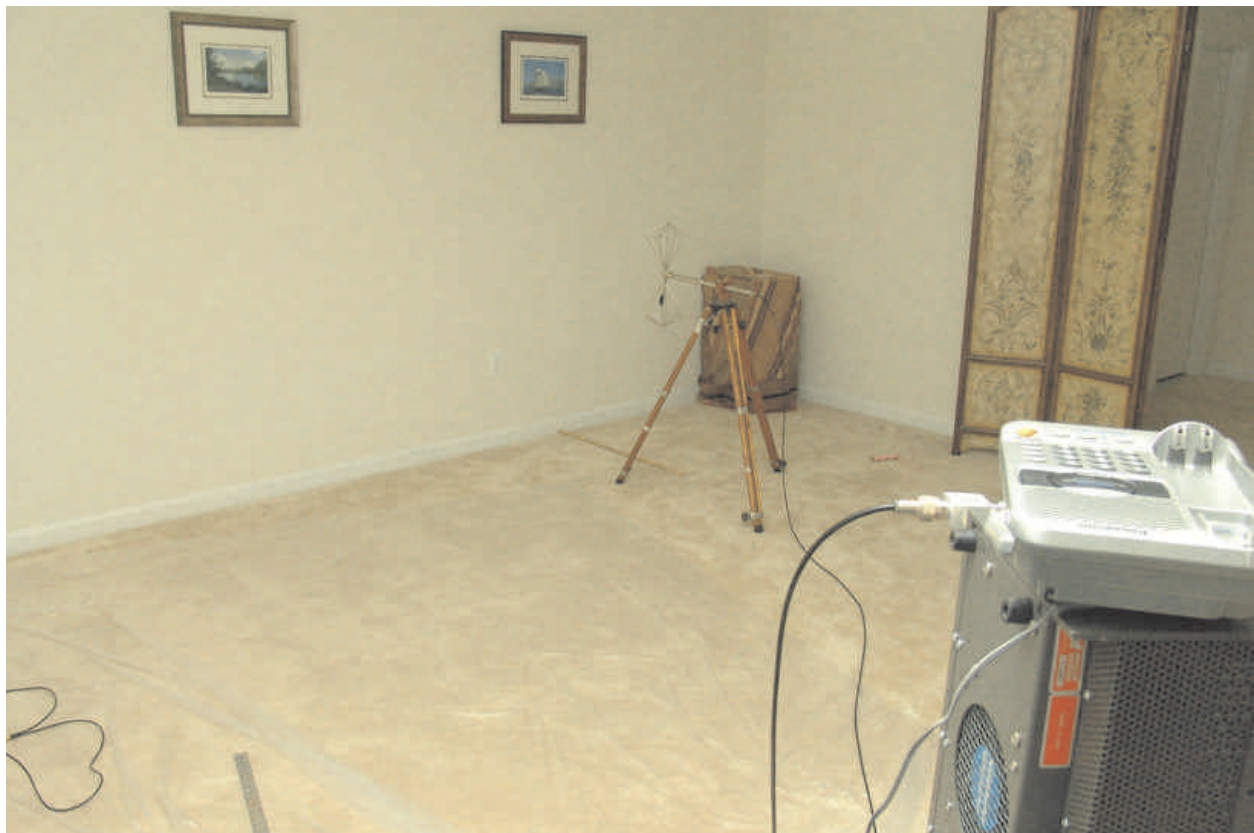
Figure 2-4. Test Site 2—View of Inter-Unit Townhouse Wall from Townhouse A During Tests at 2 Meters Separation Distance

Figures 2-4 and 2-5 show the interferer test setup in the Townhouse A for 2 meters separation distance. Figure 2-6 shows the configuration with the antenna on the other side of the room for tests at 10 meters distance. Figures 2-7 and 2-8 show the setup of a TV sample in Townhouse B for 2 meters and 10 meters separation distances, respectively.

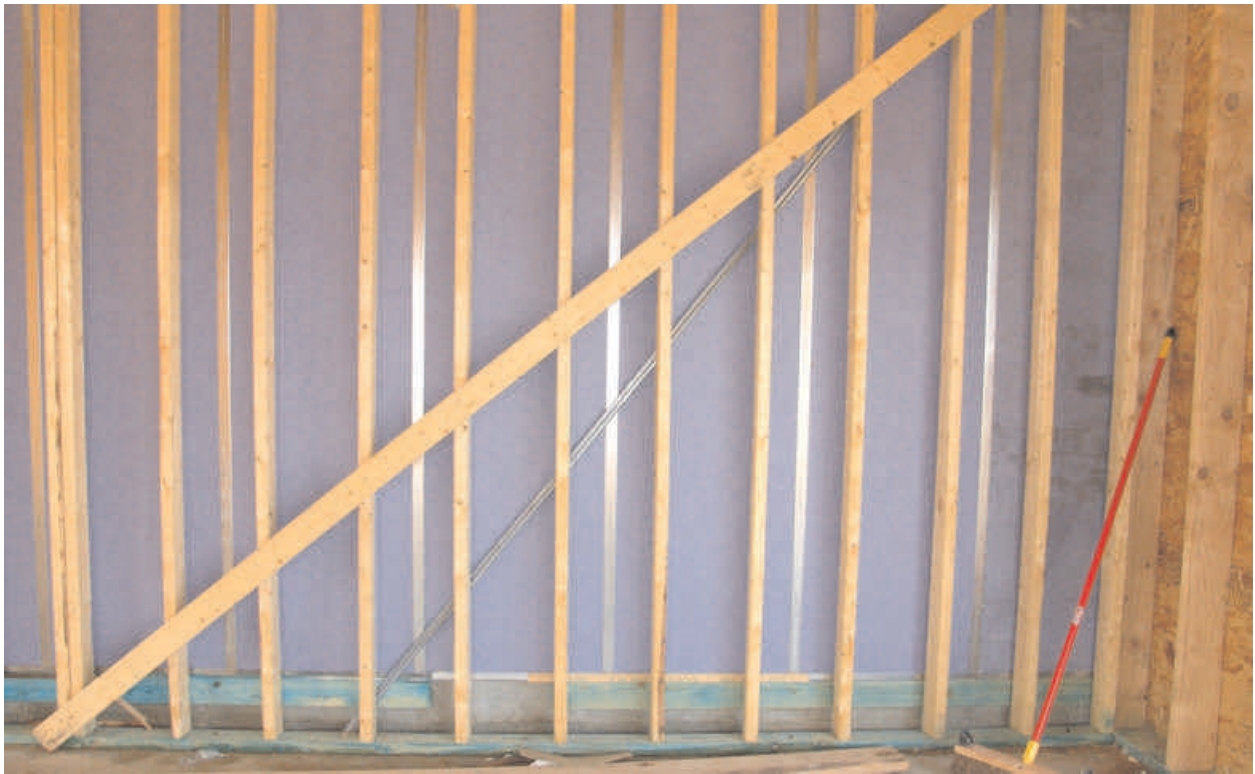
Figure 2-9. Inter-Unit Wall of a Townhouse Under Construction

The townhouse site was expected to create more complex multipath propagation between the interferer and the TV than that at the other two sites. A wrought iron bookcase can be seen in the Figures 2-7 and 2-8, 37" to left of centerline between antenna and starting position of the TV (to the right of the TV when viewed from the front of the TV). In addition, the townhouse fire wall is believed to include metallic components, based on observations of similar townhouses under construction near site 2. Figures 2-9 and 2-10 show photographs of the firewall in one of those townhouses. The gypsum firewall panels (two-inches thick) are joined by vertical steel channels on 24-inch centers, as described in Table 2-1; the firewall also includes horizontal channels at about 10-foot intervals vertically and each wall includes a diagonal metal strip.
